**Cool Designs Ltd**

# Pocket Handbook Of Technical Data For the **TOSHIBA** Range of Products

## The equipment listed within this publication are designed for R32 Refrigerant.

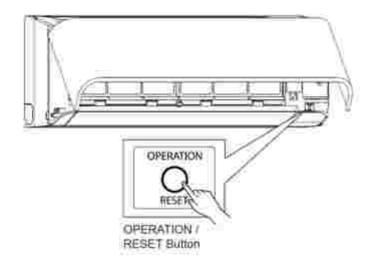
The indoor unit is equipped with an automatic restart facility that allows the unit to restart, at the last set operating conditions, after a power failure. The operation will resume without warning three minutes after power is restored.

This feature is not set up when these systems are shipped from the factory, therefore it will need to be activated by the installing company.

Generally, the process is the same for all RAS products since approx. 2001 and is as follows:

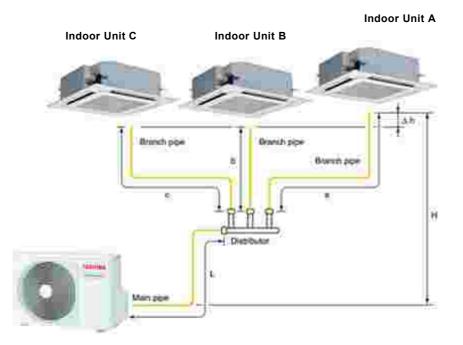
## **Digital / Super Digital Inverter Triple Splits**

#### **Pipe Specifications**

Allowa	ble Piping Lengths	(m)		Height Difference (m)			
Model (RAV-)	*Total Length La + Lb La + Lc Maximum	†Branch Piping La, Lb or Lc to Furthest Indoor Maximum	≠Subtractive Piping Length Lb - La Lb - Lc Maximum	Indoo Outdoor Unit Higher Maximum	or Unit - Outdoor U Indoor Unit Higher Maximum	Indoor Unit Higher Difference (Δh)		
GM1101ATP(8)-E								
GM1401ATP(8)-E		45	10	20	20		10	
GP1101AT-E	50	15	10	30	30	0.5	10	
GP1401AT-E

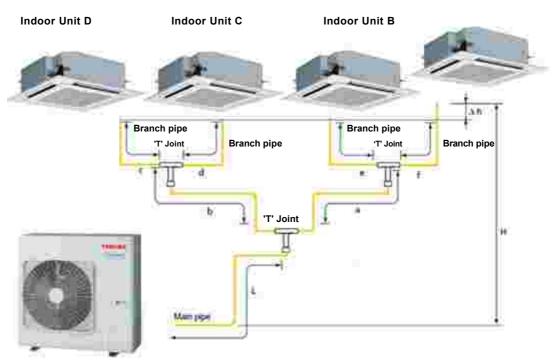
## **Digital Inverter Quad Splits**

Indoor Unit A

#### **Pipe Specifications**

Allowa	ble Piping Lengths	s (m)		Hei	ight Difference (	m)	
Model (RAV-)	*Total Length (L+b+c) or (L+b+d) or (L+a+e) or (L+a+f) Maximum	†Branch Piping c, d, e & f to Furthest Indoor Maximum	¥Branch Piping b+c b+d a+e a+f Maximum	<b>‡</b> Subtractive Branch Piping (c+b) - (d+b) (c+b) - (e+a) (c+b) - (f+a) (d+b) - (f+a) (d+b) - (f+a) (e+a) - (f+a) Maximum	Outdoor Unit- Outdoor Unit higher Maximum	Indoor Unit(H) Indoor Unit higher Maximum	Indoor unit height difference (Δh) Maximum	Number of Bent portions Maximum or Less
GM1401ATP(8)-E GP1401AT-E	50	10	15	5	30	30	0.5	10

Example 1 Installed length main pipe L to distributor=20m Installed length branch b=10m	Example 1 using GM14	401ATP(8)-E			
Installed length branch c=5m Installed length branch d=5m Installed length branch a=10m Installed length branch e=5m Installed length branch f=5m	Total pipe length Branch pipe length Branch pipe length	L - 28 x α. a + b - 4 x β c + d + e + f x γ	20 - 28 10+10- <b>4</b> 5+5+5+5	=-8 x 0.035 = =16 x 0.020 = =20 x 0.020 = Add Amount	-0.28 + 0.32 + 0.40 0.44 kg

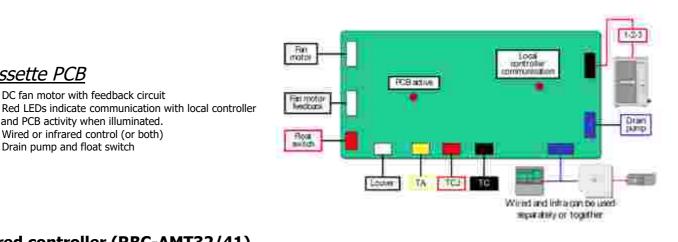
Wired or infrared control (or both)

Drain pump and float switch

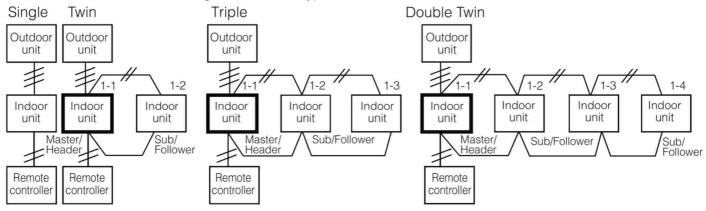
#### **Basic configuration**

The basic DI/SDI connection configuration of each type of model is shown below.

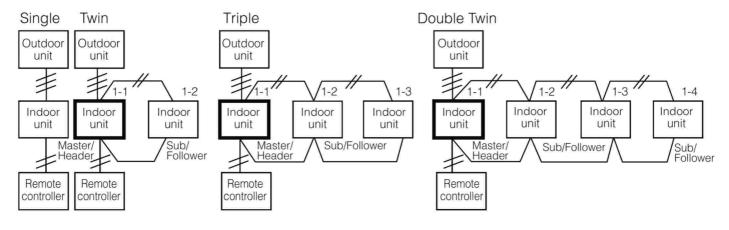
#### Standard configuration (One outdoor unit)

#### In this case, address setting can be made by using auto addressing.

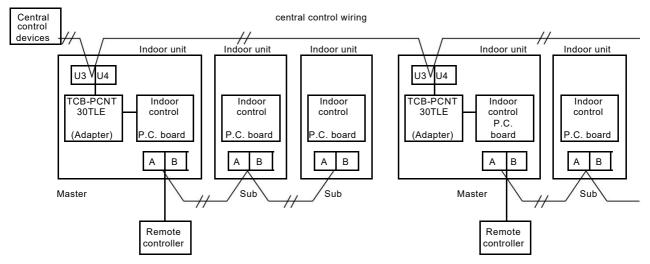
#### Cabling connection of control wiring

Attach an adaptor per 1 group in the group control operation (including individual control). Connect the adaptor to the Master indoor unit in the group control.

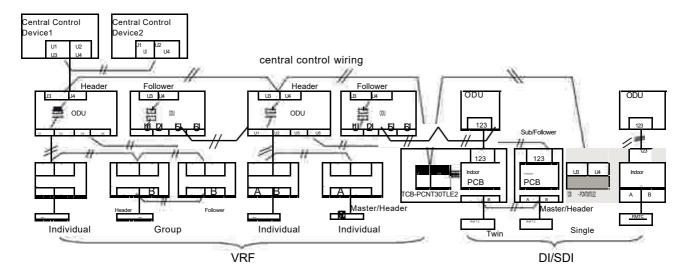
A central control connection example of a system where both VRF and DI/SDI are used is shown below. The VRF and DI/SDI subsystems are connected through the central control wiring and to the central control devices.

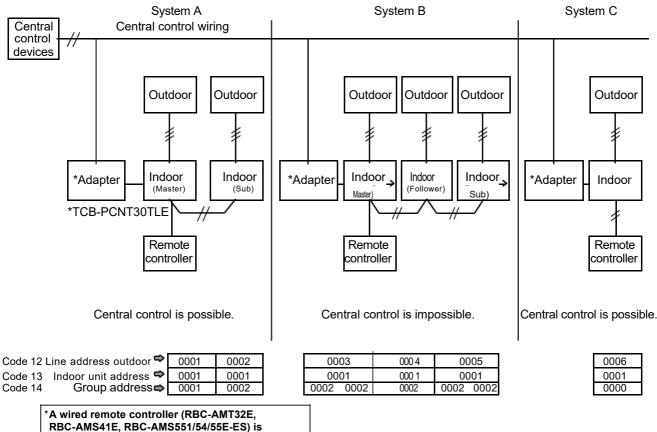
### Network Addressing DI/SDI and VRF Systems

When the central control is performed for indoor units using twin control in a group operation, it may be required to change the group address. (Adapter is attached to the Lead indoor unit.)

**Reason:** The central control device communicates with each individual indoor unit, the Lead indoor unit of the group control and the Lead indoor unit of the twin control. However, as the address is automatically set up, which unit will become the Lead unit is indefinite. Therefore, if the unit attached with adapter does not become the Lead indoor unit, the central control function will become unavailable.

required for address change.
